Lessons from the Challenger Launch Decision¹

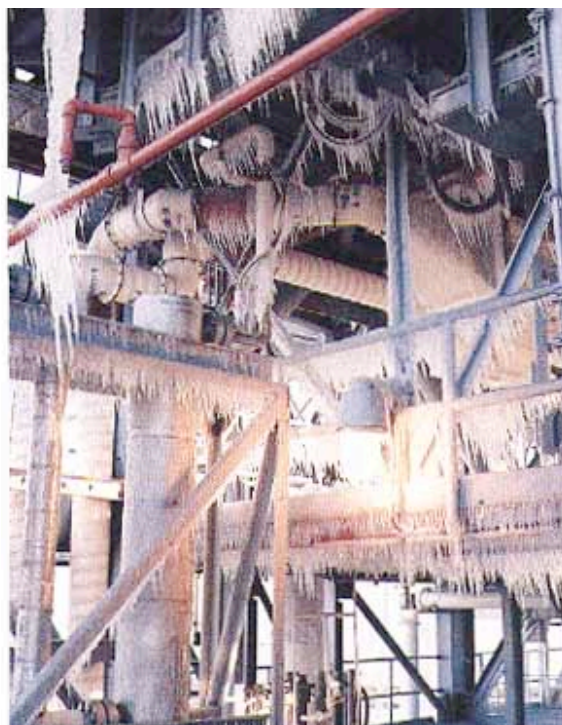
The ambient air temperature at launch was 36 degrees Fahrenheit. This temperature was 15 degrees colder than that of any previous launch. See **Figure 2**.

Figure 2: Ice on the Launch Tower Hours before the Launch. Source: NASA Image.

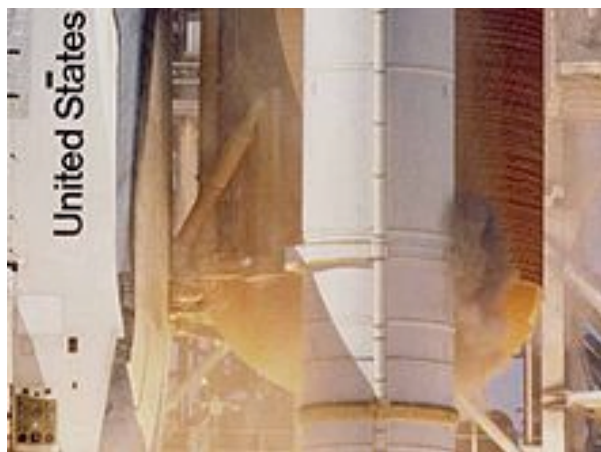
Figure 3: Grey Smoke Emitting from the Right-Hand SRB on Space Shuttle Challenger. Source: NASA Image.

Just after liftoff at 0.678 seconds into the flight, photographic data (**Figure 3**) shows a strong puff of gray smoke was spurting from the vicinity of the aft field joint on the right SRB. The computer graphic analysis of the film from the cameras indicated the initial smoke came from the 270- to 310-degree sector of the circumference of the aft field joint of the right SRB. This area of the solid booster faces the external tank. The vaporized material streaming from the joint indicated that there was not complete sealing action within the joint.

Eight more distinctive puffs of increasingly blacker smoke were recorded between 0.836 and 2.500 seconds. The smoke appeared to puff upwards from the joint. As the Shuttle increased its upward velocity, it flew past the emerging and expanding smoke puffs. The last smoke was seen above the field joint at 2.733 seconds.

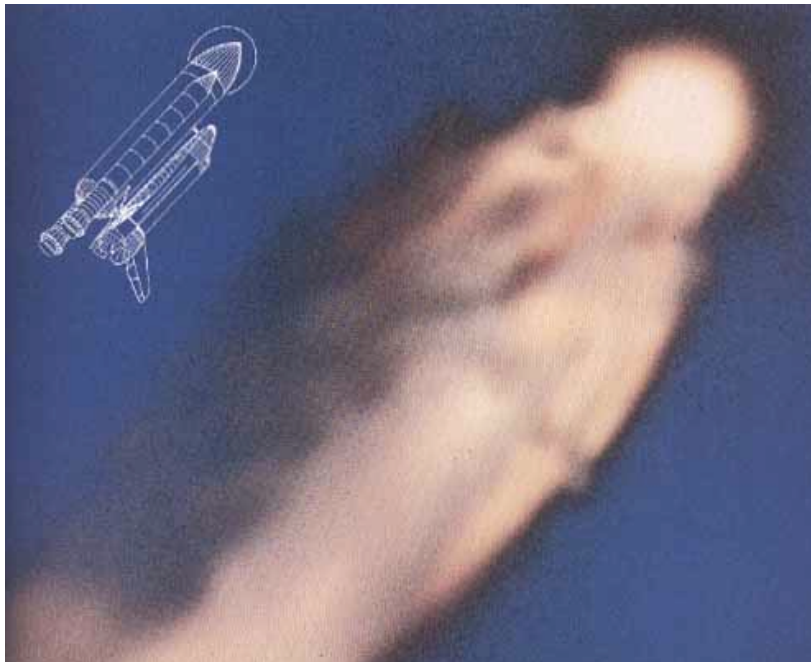
At 73.124 seconds, a circumferential white vapor pattern was observed blooming from the side of the external tank bottom dome (see **Figure 4**). This was the beginning of the structural failure of the hydrogen tank that culminated in the entire aft dome dropping away. This released massive amounts of liquid hydrogen from the tank and created a sudden forward thrust of about

2.~3 million pounds, pushing the hydrogen tank upward into the intertank structure. At about the same time, the rotating right SRB impacted the intertank structure and the lower part of the liquid oxygen tank.

Figure 4: Rupture of the Liquid Oxygen Tank, which Occurred above the Booster/Tank Forward Attachment and Grew in Milliseconds to the Maximum Size Indicated in the Computer Drawing. Source: NASA Image.

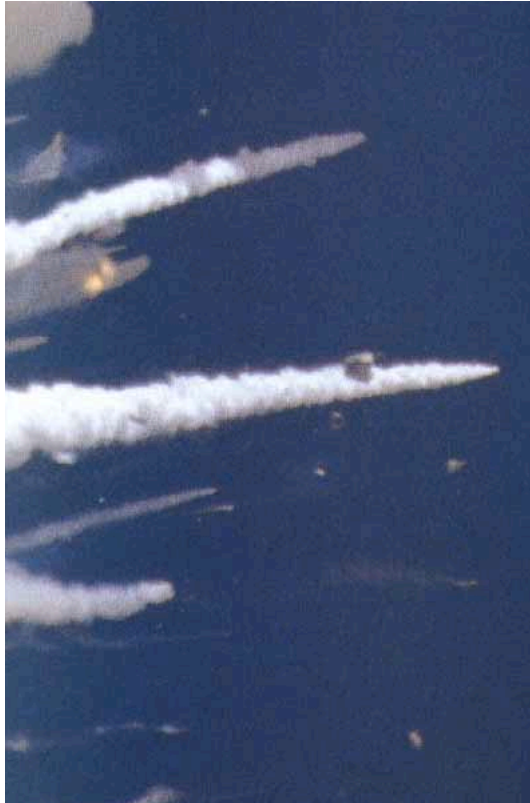
Figure 5: Large Sections of the Orbiter Emerged from the Fireball. Source: NASA Image.

Within milliseconds, there was massive, almost explosive burning of the hydrogen streaming from the failed tank bottom and the liquid oxygen breach in the area of the intertank. The *Orbiter*, under severe aerodynamic loads, broke into several large sections, which emerged from the fireball (**Figure 5**). Separate sections that can be identified on film include the main engine/tail section with the engines still burning, one wing of the *Orbiter*, and the forward fuselage trailing a mass of umbilical lines pulled loose from the payload bay. The crew cabin with all the crew inside was found in 100 feet of water on March 8th. They were all still strapped in their seats. Some had activated supplemental oxygen. All would have died, when the cabin hit the water at an estimated 200 miles per hour if they survived the fall.

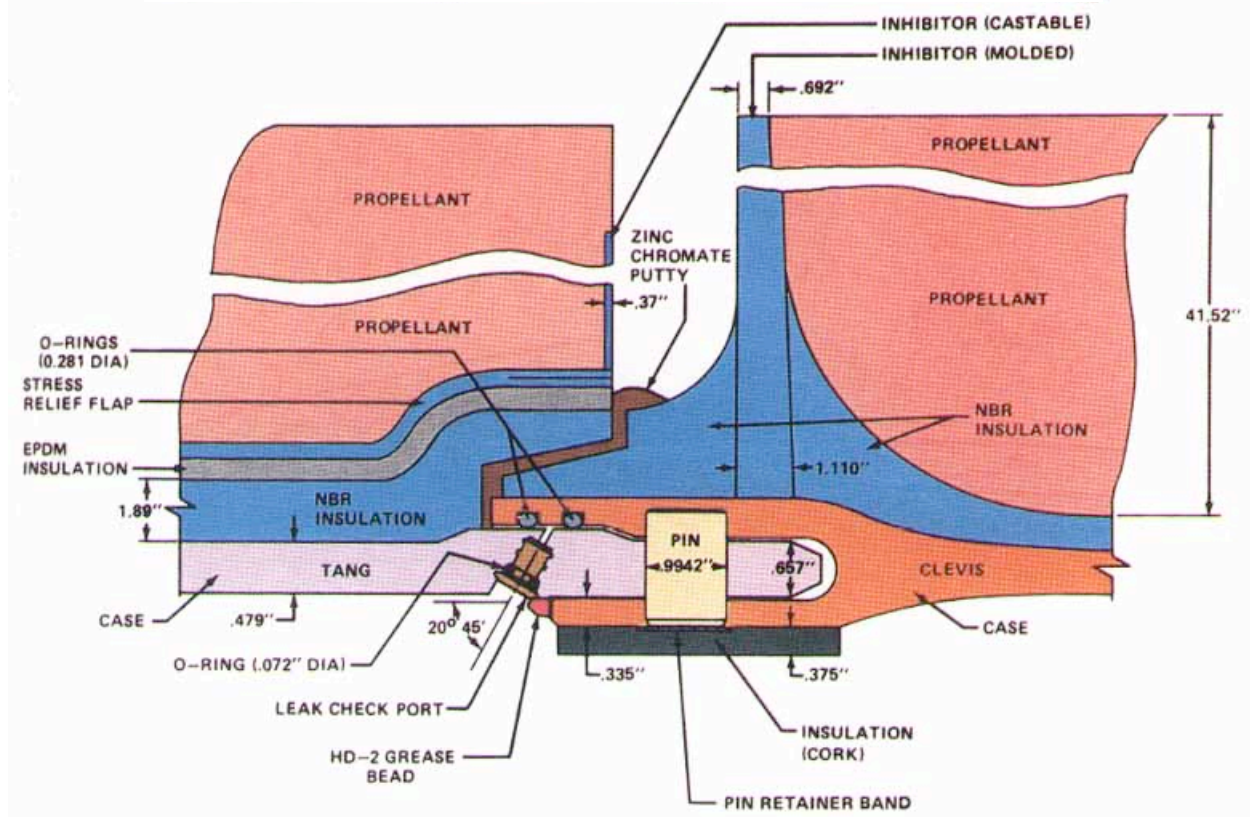
Enhanced photographic and computer-graphic positioning determined that the flame from the right SRB near the aft field joint emanated at about the 305-degree circumferential position. The smoke at lift off appeared in the same general location. Thus, early in the investigation the right SRB aft field joint seal became the prime failure suspect. This supposition was confirmed when the salvage team recovered portions of both sides of the aft joint where a hole had burned through that was 28 by 15 inches. Several possible causes could have resulted in this failure.

The displacement of the putty would act like a piston and compress the air ahead of the primary O-ring, and force it into the gap between the tang and clevis. This process was known as pressure actuation of the O-ring seal. This pressure-actuated sealing was required to occur

very early during the solid rocket motor ignition transient, because the gap between the tang and clevis increased as pressure loads were applied to the joint during ignition. Should pressure actuation be delayed to the extent that the gap has opened considerably, the possibility existed that the rocket's combustion gases would blow by the O-ring and damage or destroy the seals. The principal factor influencing the size of the gap opening was motor pressure; but, gap opening was also influenced by external loads and other joint dynamics. See **Figure 6** and **Figure 7** for images of the SRB.

Figure 7: Aft Segment/Aft Center Segment Field Joint Configuration.
Source: NASA Image.
